WAUBEEKA LAKE DAM

CT 00065

PHASE I INSPECTION REPORT

NATIONAL DAM INSPECTION PROGRAM

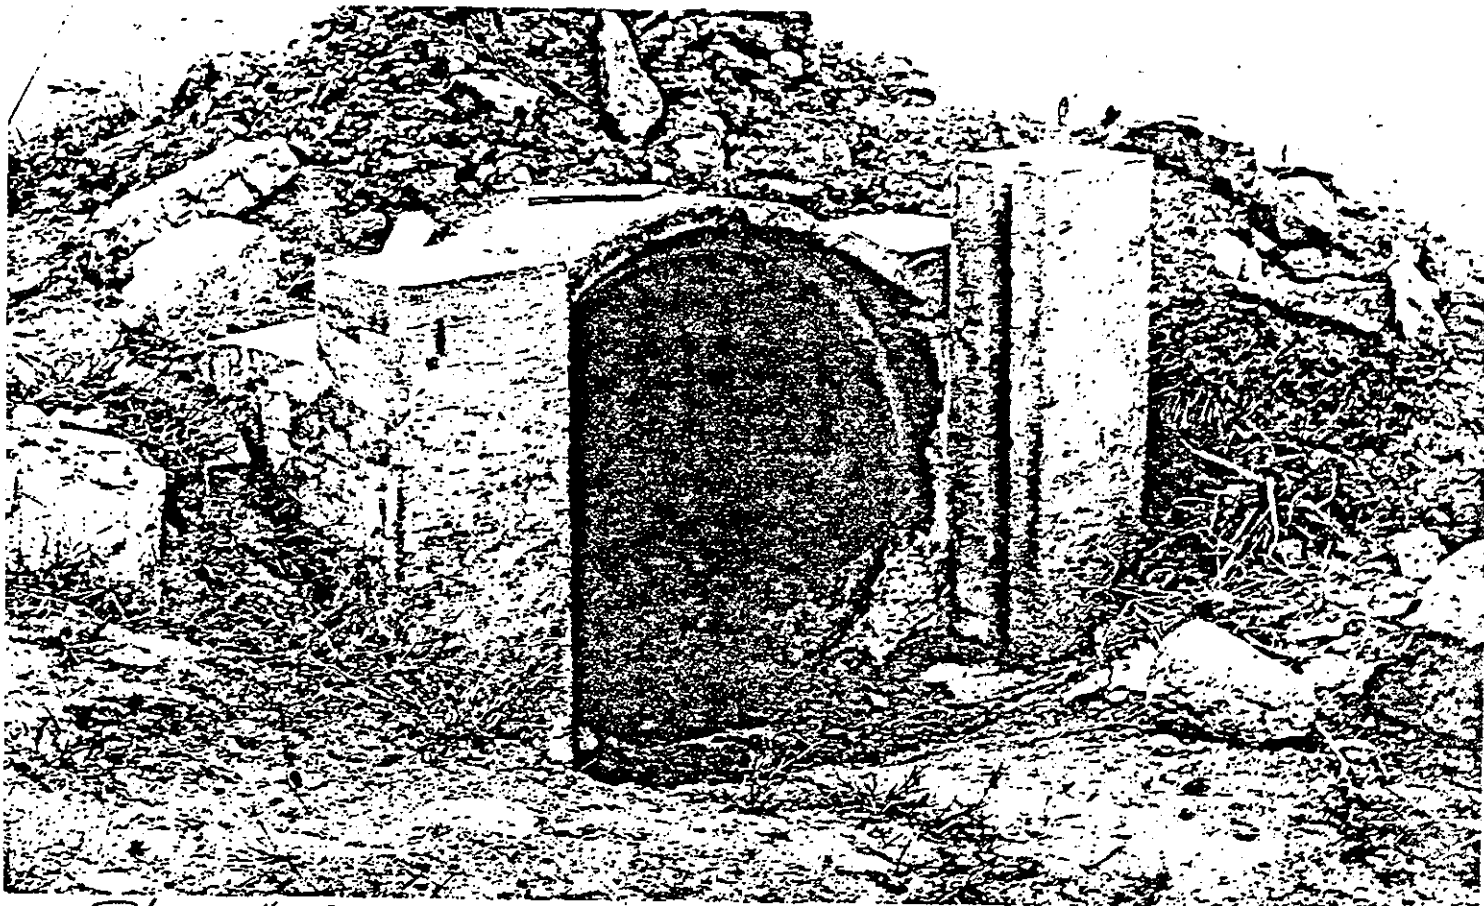
Photo #12

This is close-up of headwall recently constructed at inlet end of 36" ϕ drain from Lake. See photo #6, made 3/10/66, for original condition here..

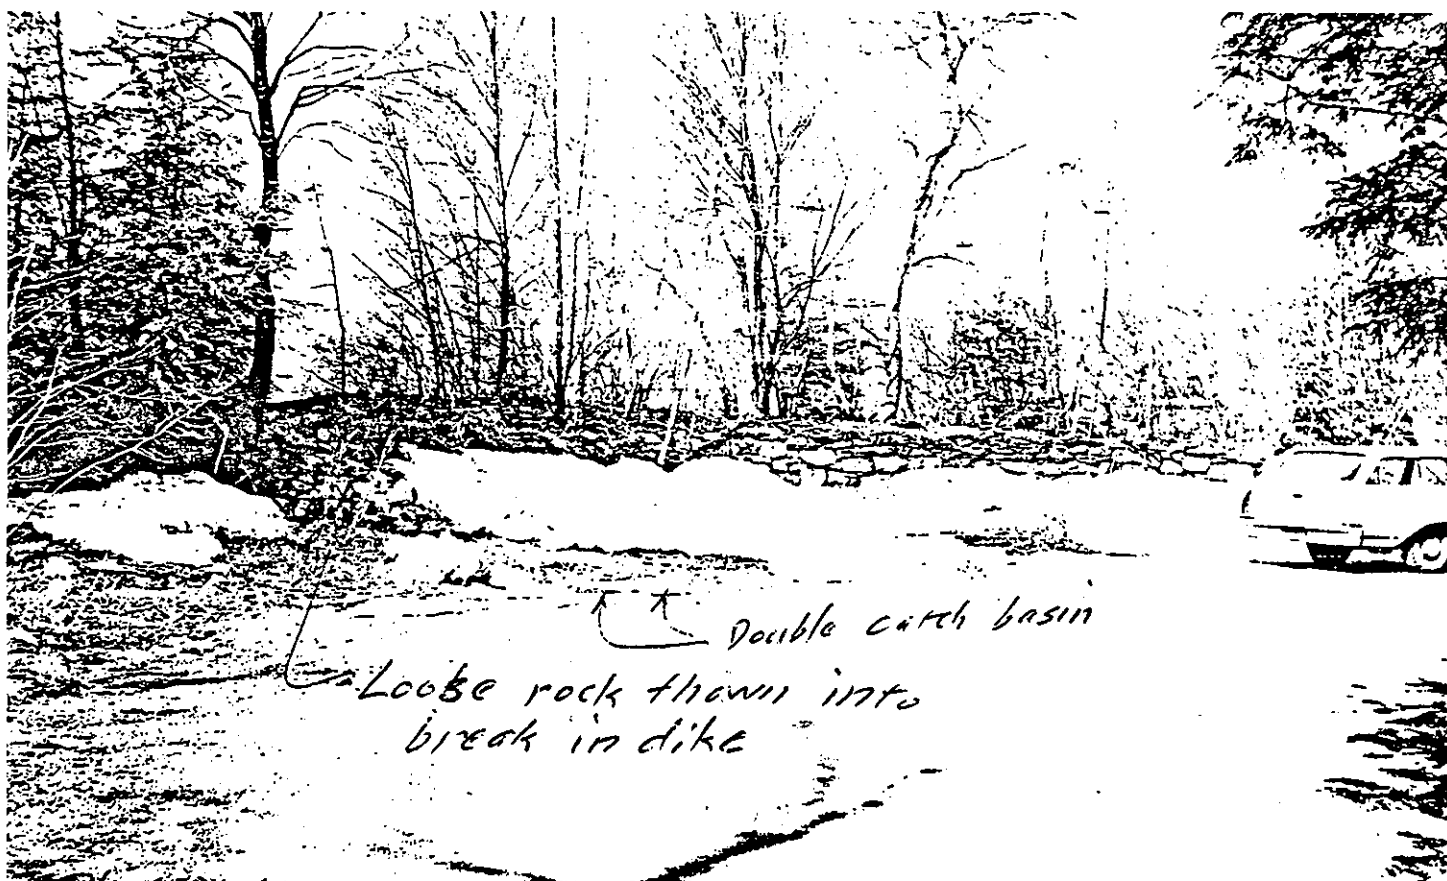
Photo #11

Dike of E. side of Lake. Stone wall,
visible above snow, supports earth fill.
Road in foreground.

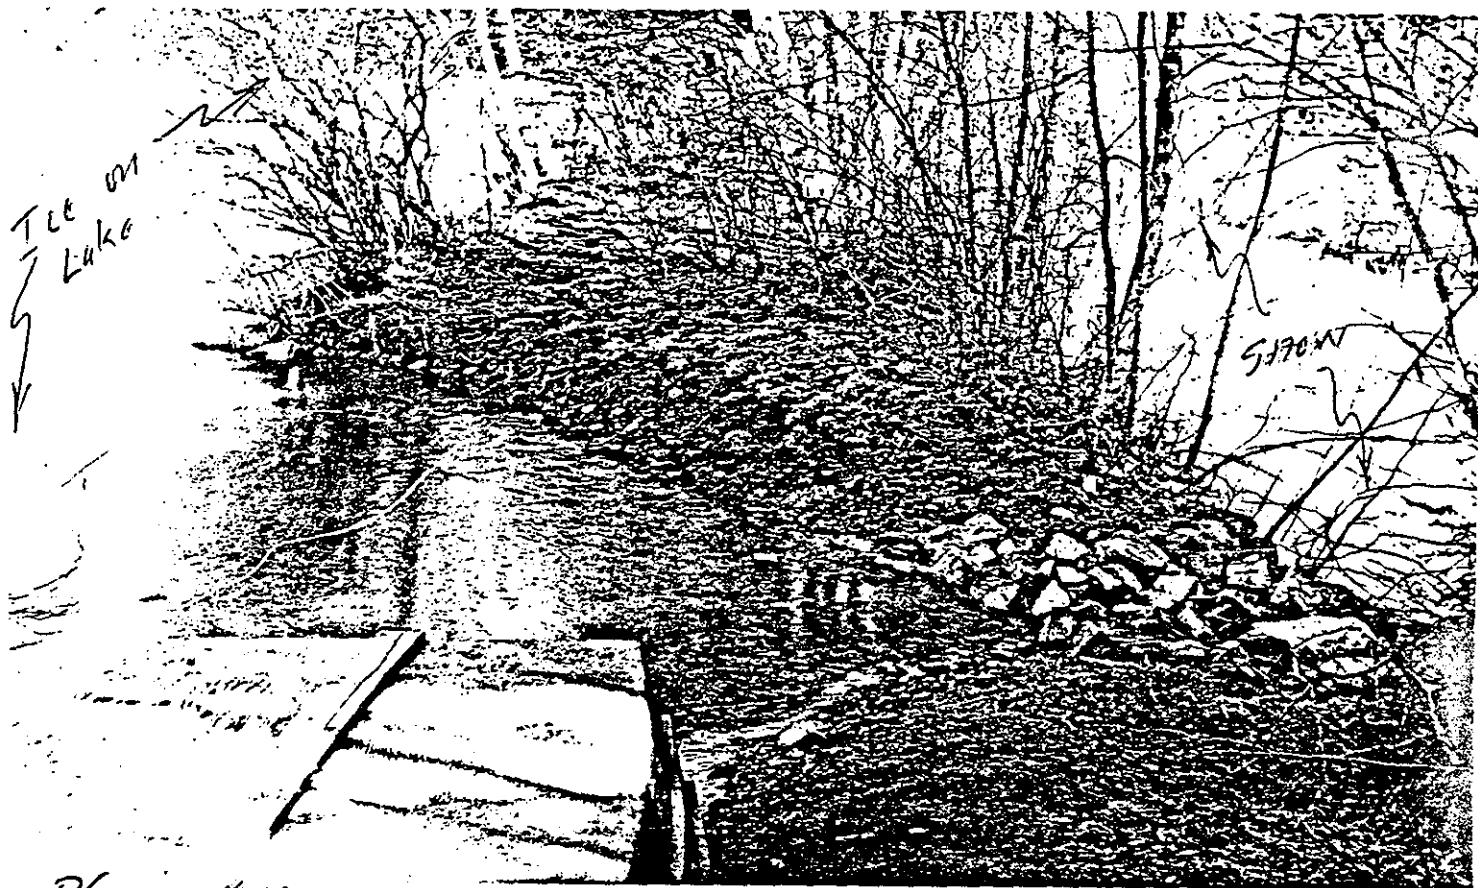
Photo #10

Break in dike on E. shore
of Lake - note loose stone
thrown into break.

It is recommended that a head wall be constructed at the intake end of the 36" ϕ pipe culvert on the west side. On the east side the break in the dike should be repaired with properly compacted earth fill and, where required, raised so that there will be a freeboard of at least 2' for it's entire length. Also, some stone rip-rap should be placed along the water side of the dike to prevent any erosion in case of even slight wave action.

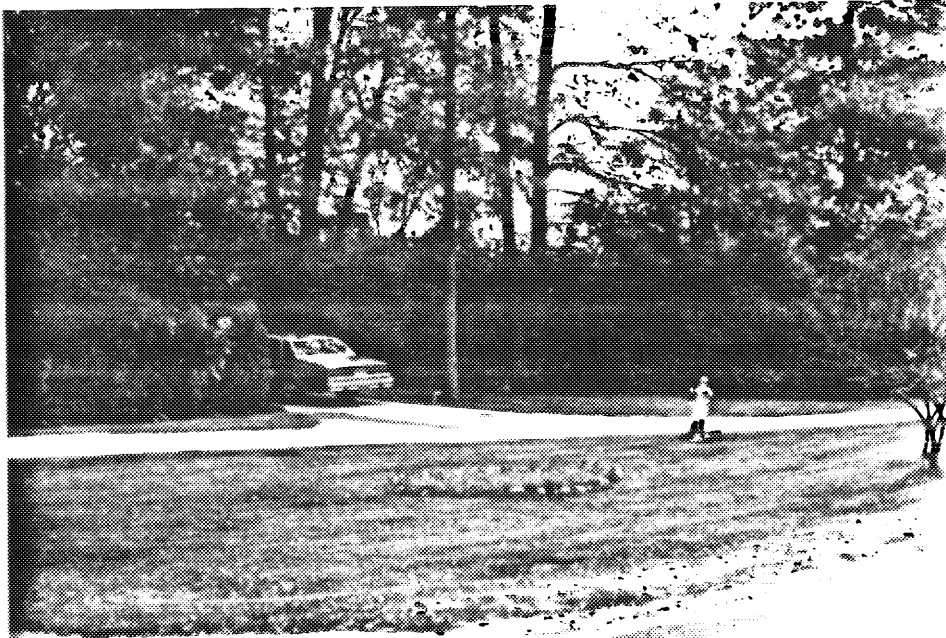
Photo 1 Downstream face and right abutment of dam on west side of Waubeeka Lake. First floor of home in impact area is defined by the deck, left.

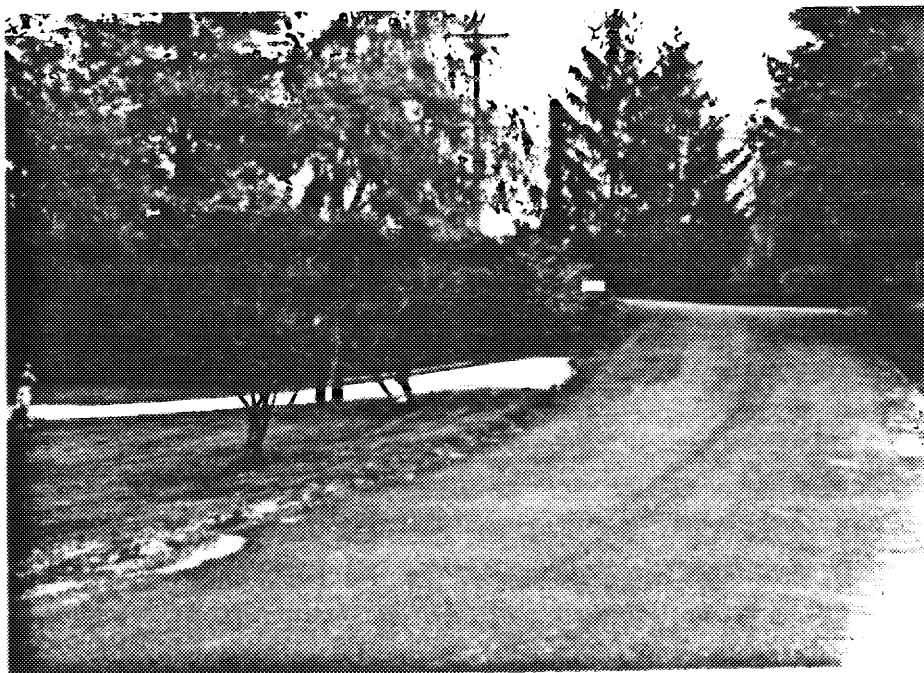
Photo 2 Downstream face of dam and Alan Road. (West Dike).

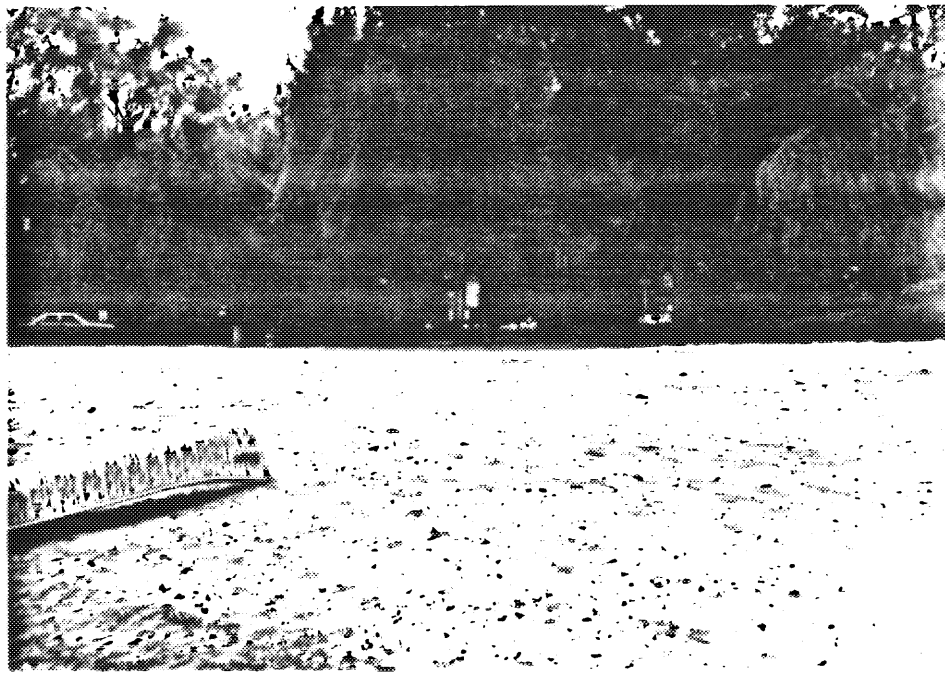
The West Dike consists of a road embankment built along a natural saddle which lies between hills forming a ridge along the western and southern fringes of the lake. The upstream slope of the dike is a small beach (Waubeeka Lake Beach) which slopes to the lake's edge at about 1V:10H

(Photo 3). The top of the dike (El. 718 NGVD; Note: all elevations referenced to the National Geodetic Vertical Datum) is a 30-foot-wide two-lane paved road (Post Road). The downstream slope in the vicinity of the culvert was measured at 1V:3H and is entirely covered with small trees (2 to 6 inches in diameter) and brush (Photos 1 and 2). A 3-foot-diameter by 120-foot-long concrete culvert (Intake Invert El. 712) drains excess water build-up from the lake (Photo 4). During the summer, months the culvert intake is filled with sand to within 1.5 feet of the culvert crown to elevate the recreation pool.

Photo 3 Upstream face of dam - Waubeeka Lake Beach (West Dike).

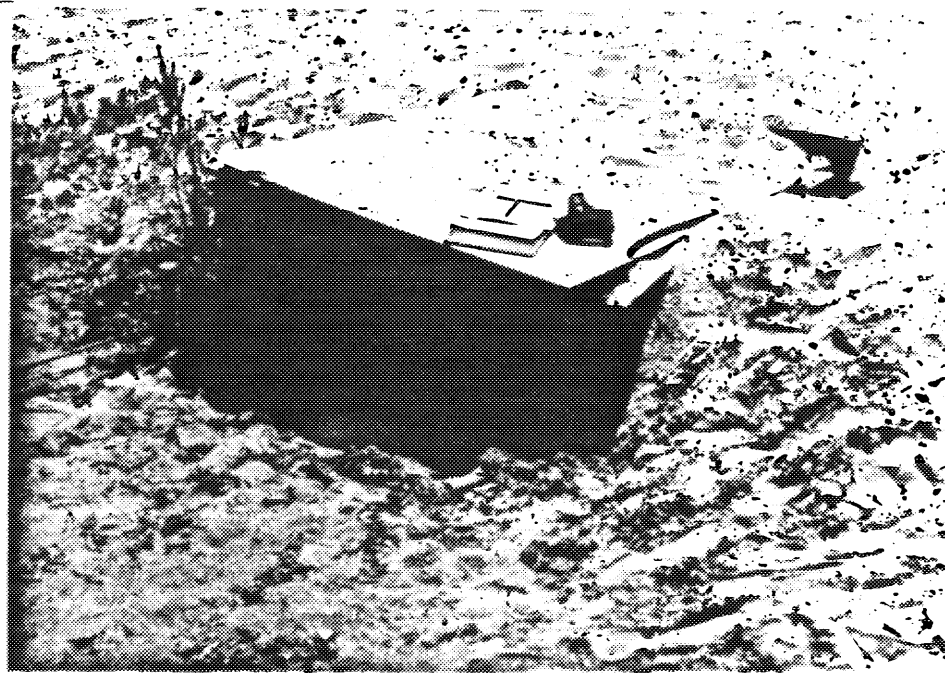
Photo 4 Intake of 3-foot diameter concrete conduit at dam (West Dike).

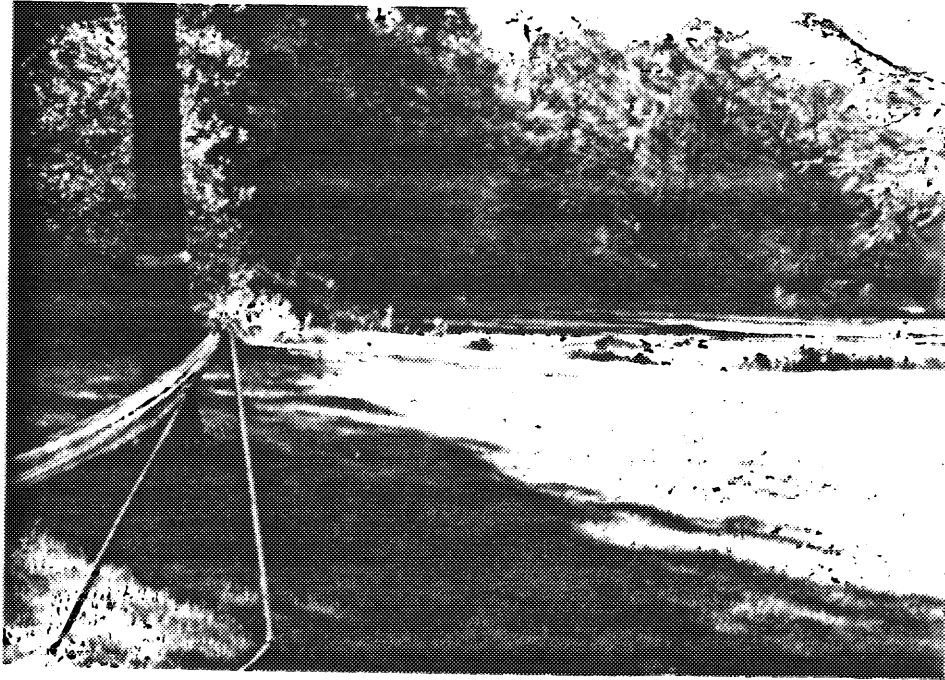
Photo 5 Landfill at southern end of lake.

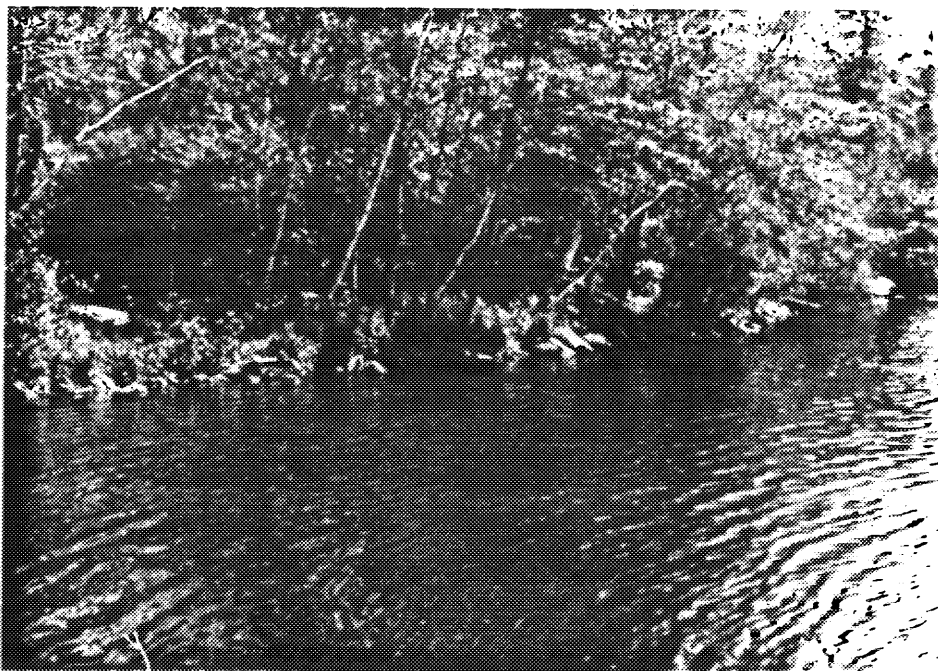
The East Dike is a 225-foot-long by 3-foot-high earthfill structure with a vertical downstream masonry face and an inclined upstream face which is entirely covered with riprap (Photos 6 and 7). The top of the dike varies from El. 713.3 to El. 714.5 and is approximately 15 feet wide. This variation in elevation occurs in the vicinity of the repaired breach. During the 1955 flood, flow over the top of the dike swept away a 20 to 30-foot-wide section of the dike. This breached area was later restored and no further incidents of this nature have occurred to date. The top and downstream toe are overgrown with trees ranging from 2 to 10 inches in diameter. In addition, a two-lane paved road (Carol Street) was constructed 20 feet from the downstream face of the dike during the development of the Waubeeka Lake community. A storm drain located at the roads edge, adjacent to the dam, collects runoff and pipes it under Carol Street to a point approximately 50 feet downstream of the dike. At the time of the inspection, fine tan deposits were found at the bottom of the storm drain discharge channel (Photo 8). The origin of this material could not be identified.

Photo 6 Upstream face of East Dike.

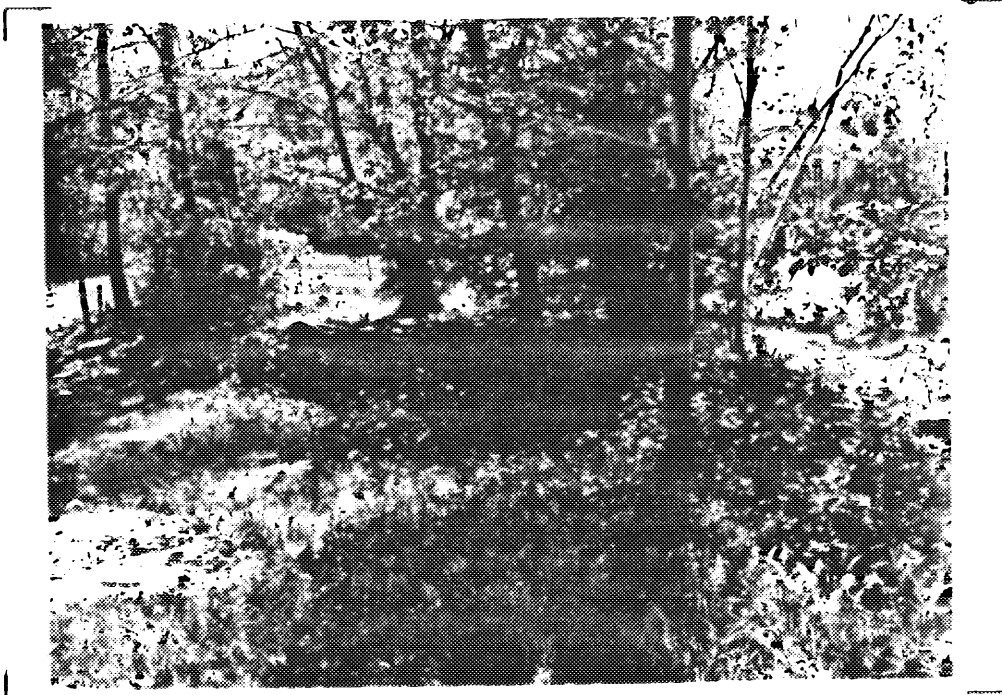
Photo 7 Downstream face of East Dike

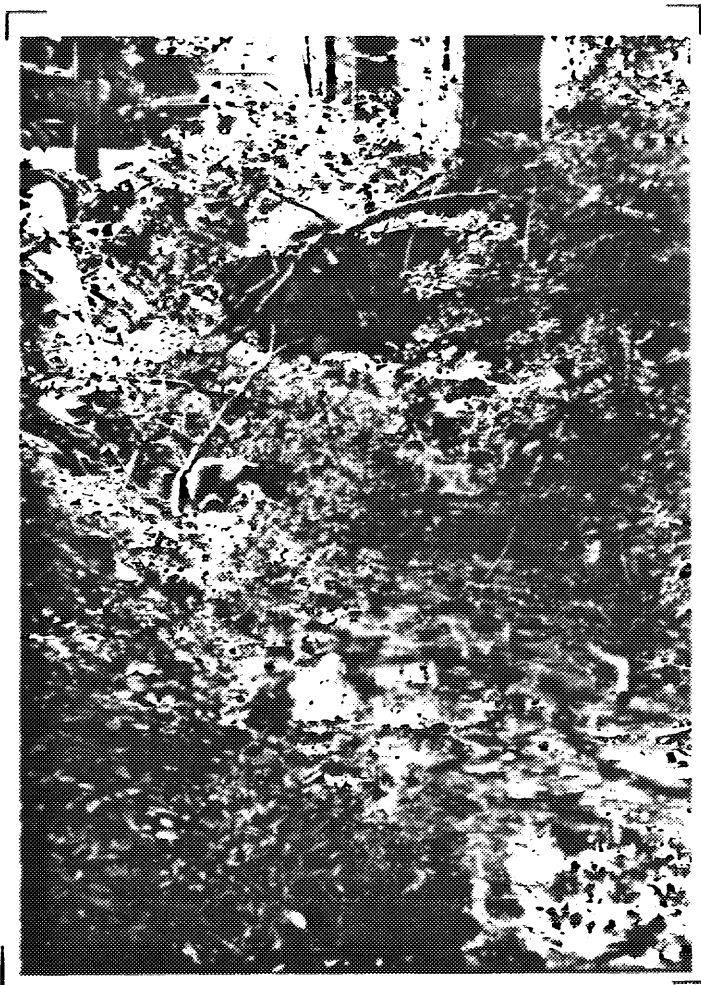
Photo 8 Discharge stream from
storm drain located on road
downstream of East Dike.
